SCHONENBERG ESTATE

Environmental Compliance Audit Report 2015

Date:
December 2015

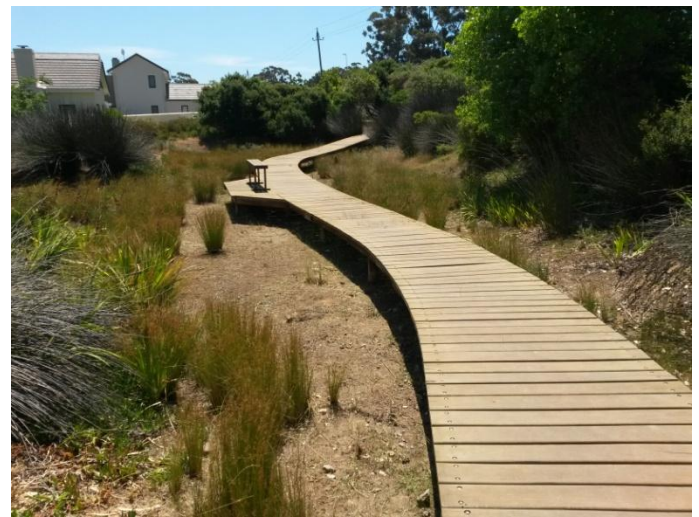
Photo 4: The boardwalk crossing the area of public open space near the north-west corner of the Estate.

- Boardwalks around the Estate (such as those shown in Photo's 4 and 7) are all maintained in good condition. One of the paths through the seep has been closed. Another, along the western edge of the northern part of the seep was proposed for closure, but has remained open (Photo 11). It is the opinion of the auditor that maintaining this path as a walkway for residents will not have an adverse effect on the ecology of the seep.

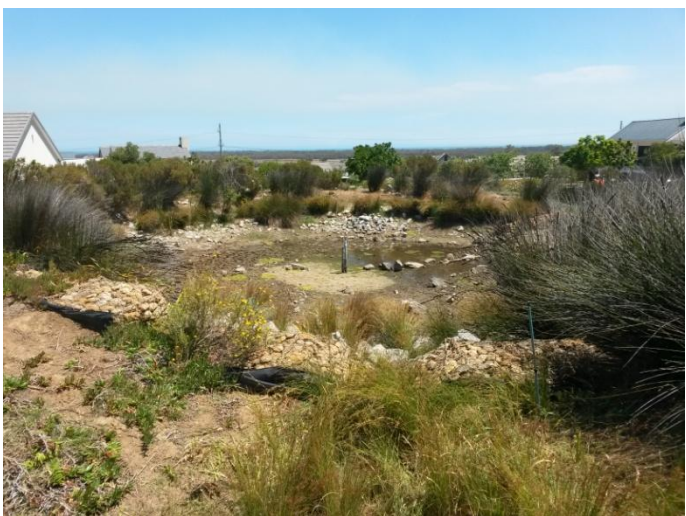
Photo 5: One of the dams near the north-west corner of the Estate. Note the lack of water, attributed to low rainfall.

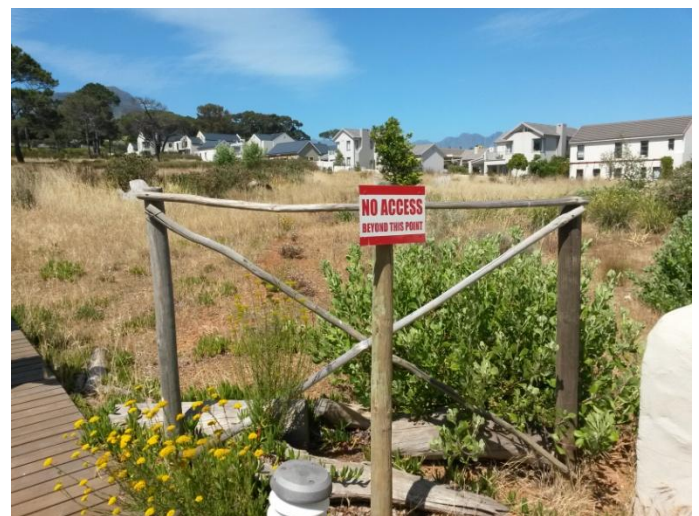
- One of the pathways through the seep area has been closed to access (Photo 6). A fence has been placed across the entrance/exit points of the path, and signs declaring “no access beyond this point” have been erected. This has been done in an effort to prevent further disturbance to the seep area, and allow the decommissioned pathway to rejuvenate.

Photo 6: One of the entrance points of the closed pathway through the seep.

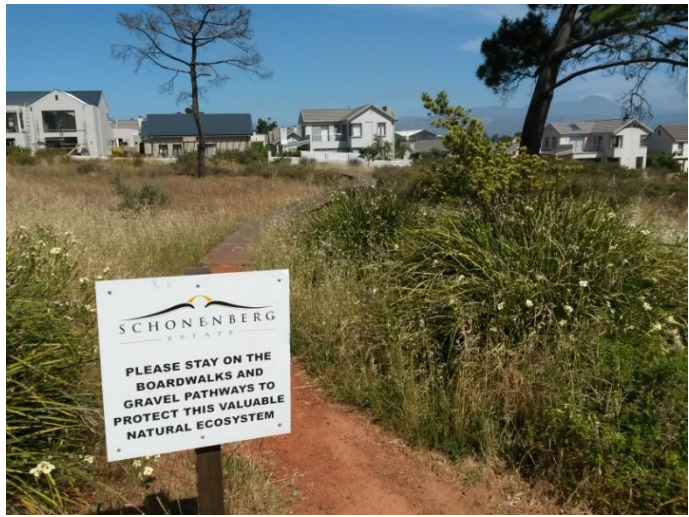
Photo 7: One of the sign boards placed around the seep conservation area.

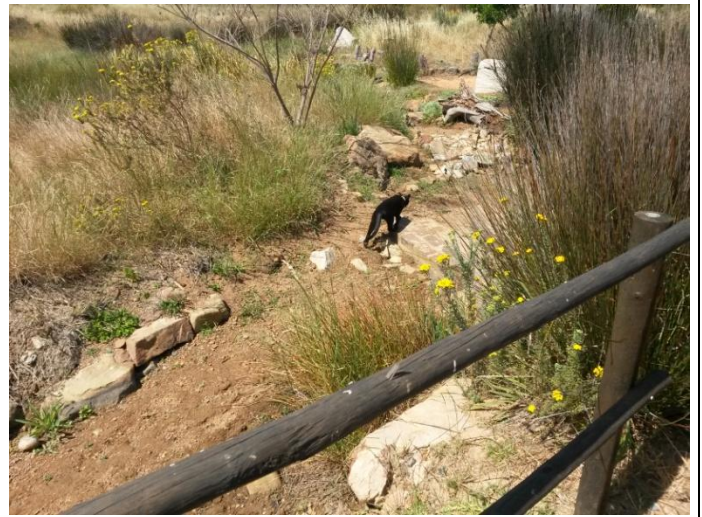
- The management of domestic animals within the Estate must adhere to the City of Cape Town's regulations for keeping domestic animals.
- Various bird species were observed during the time of the site visit.
- There is still concern with regards to the use of the seep by domestic animals, particularly cats (Photo 8). While it is acknowledged that there is little the SHOA can do about the situation, it was reported that the seep area is being monitored by residents and this is having an effect and residents are reporting when people and pets enter the seep area.

Photo 8: A domestic cat, spotted in the seep conservation area.

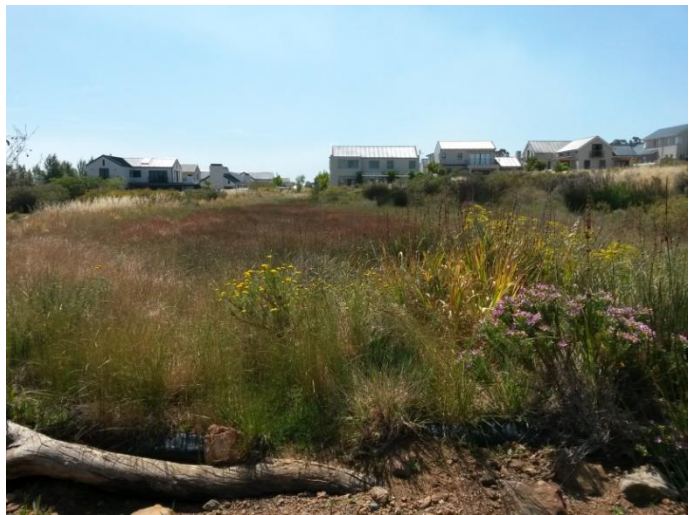
Photo 9: View of the lower part of the seep conservation area.

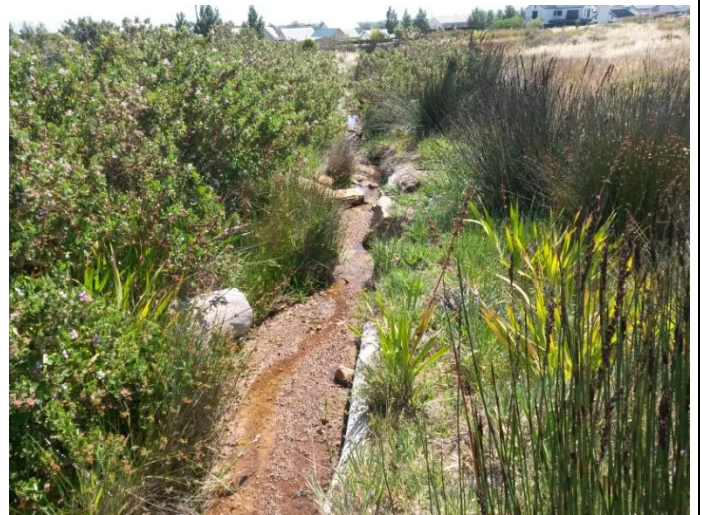
Photo 10: One of the small naturalised streams in the seep area.

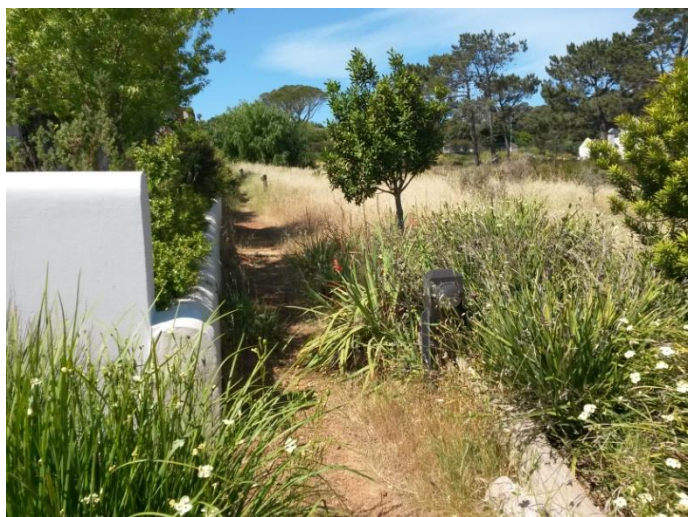
Photo 11: One of the gravel paths on the edge of the seep area. Discussions regarding the closure of this particular path are still continuing.

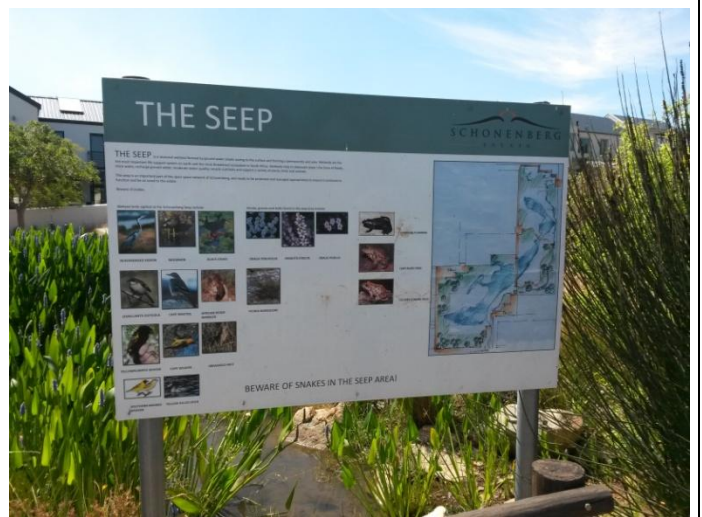
- A number of sign boards (Photo 7 and 12) have been placed at the entrances to the conservation area and along the pathways in order to provide general information about the plants and animals associated with the wetlands, as well as highlighting the importance of staying out of such areas.

Photo 12: One of the information boards that have been placed around the seep.

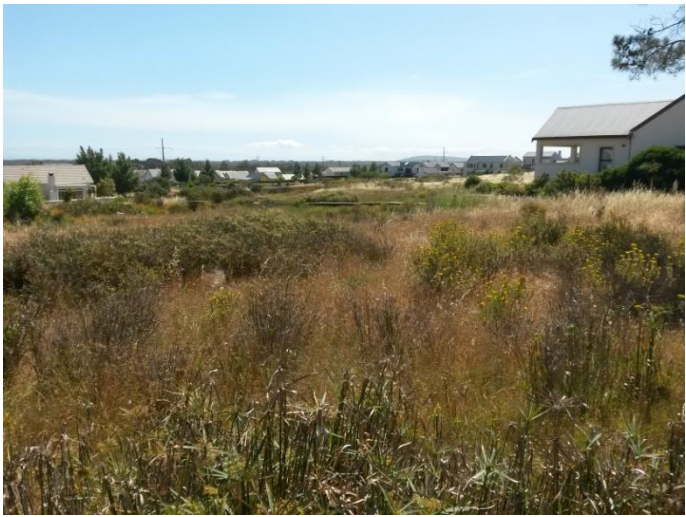
Photo 13: View of the upper part of the seep area.

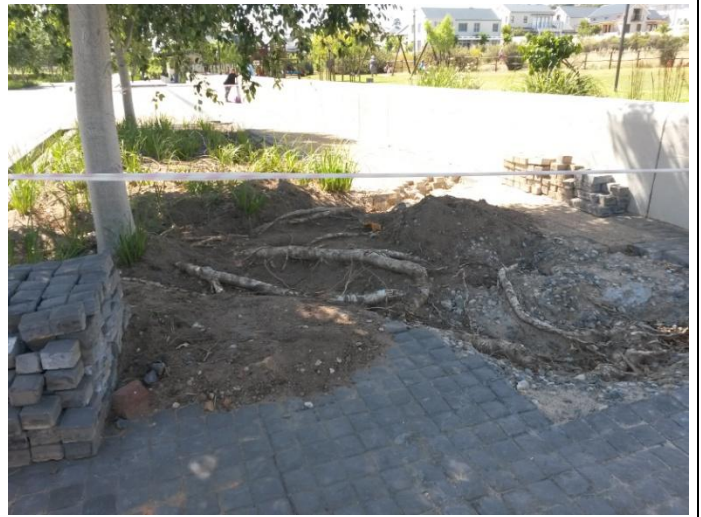
- Some of the poplar trees, planted on road verges during the Estate's landscaping phase, are now beginning to cause upliftment of the surrounding pavement (Photo 14).

Photo 14: Tree roots from the road-side poplars are causing lifting of pavement surfaces.

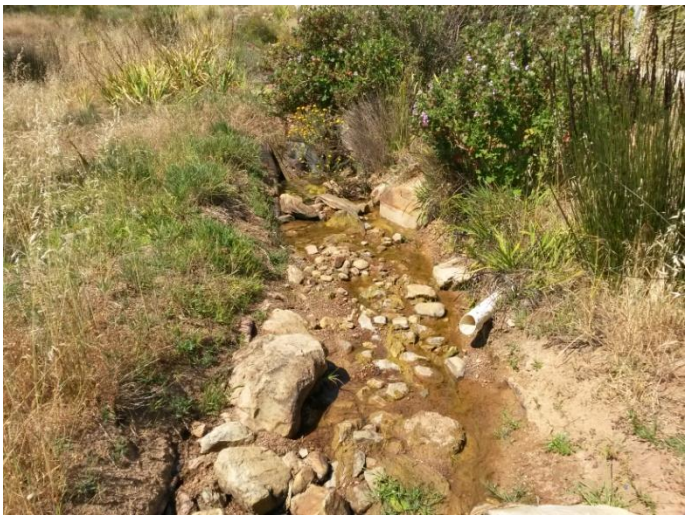
- Areas susceptible to erosion are monitored on a monthly basis.
- Some areas of the seep were a matter of concern during the previous audit. Work has been done in this area, and is continuing (Photo 15).
- Erosion gullies have begun to develop along the bank of the main road, near the north-east side of the Estate. The City of Cape Town recommended the construction of a lined channel to guide water through this area and prevent future erosion. This will be done.
- No signs of erosion elsewhere were noted during Auditor's walk through the estate. The SHOA has appointed Franz Wium to perform the functions of an ECO to monitor individual house construction. During his inspections erosion will be addressed when noted in construction areas.

Photo 15: A stream in the seep area was noted as a potential area of concern in the previous audit.

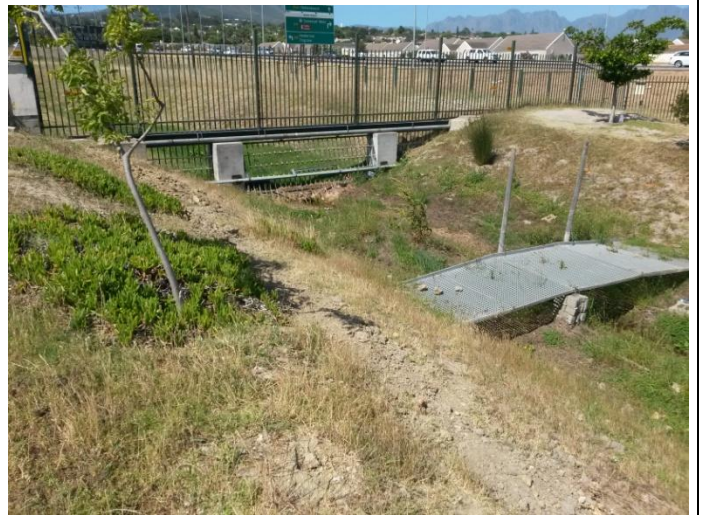
Photo 16: The point where the drainage channel along the eastern boundary enters the estate. The Waterstone complex is just upstream of this point.

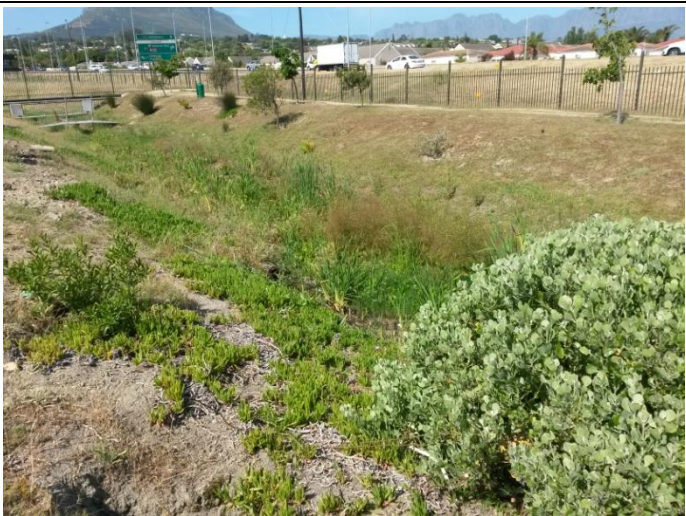
Photo 17: The channel along the eastern boundary of the Estate.

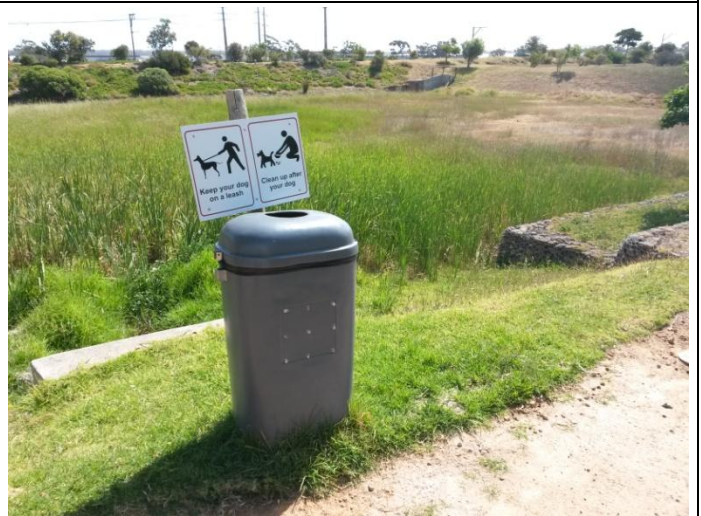
- A dog management group has been founded and disbanded in the last year. The effect of this was to place more litter bins around the estate, in which residents could place their dog waste (Photo 18).

Photo 18: Signs and litter bins put in place through the efforts of the dog control group.

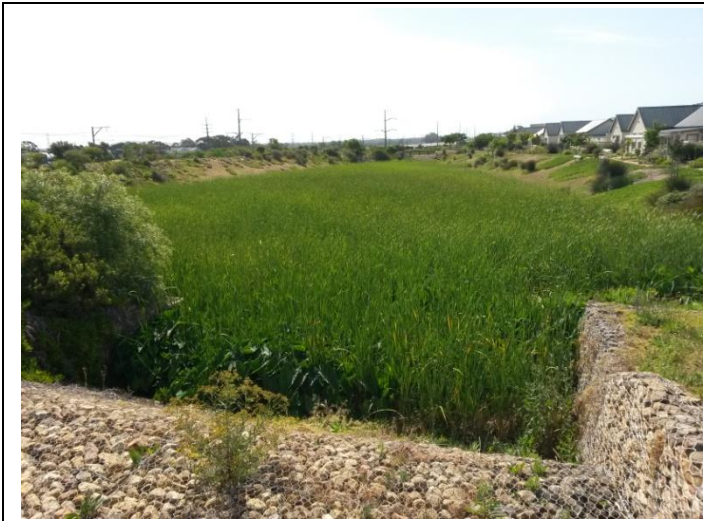
Photo 19: One of the retention ponds, stocked with fully grown bulrushes.

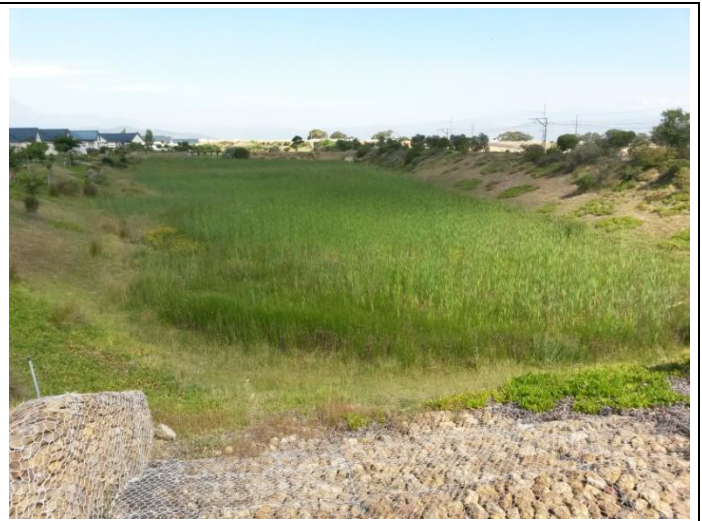
Photo 20: Another of the retention dams, containing bulrushes that were cut recently, and have subsequently begun to re-grow.

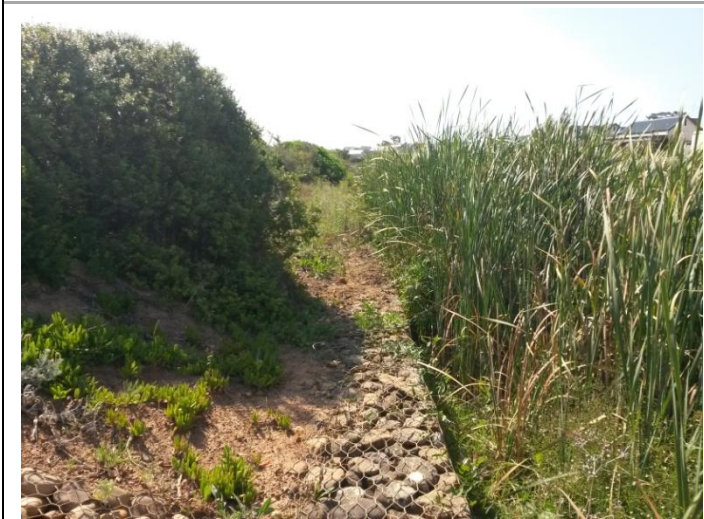
Photo 21: During the previous audit, it was noticed that this area had been dredged by a digger-loader. This area has subsequently rehabilitated itself and little (if any) sign of the activity remains.

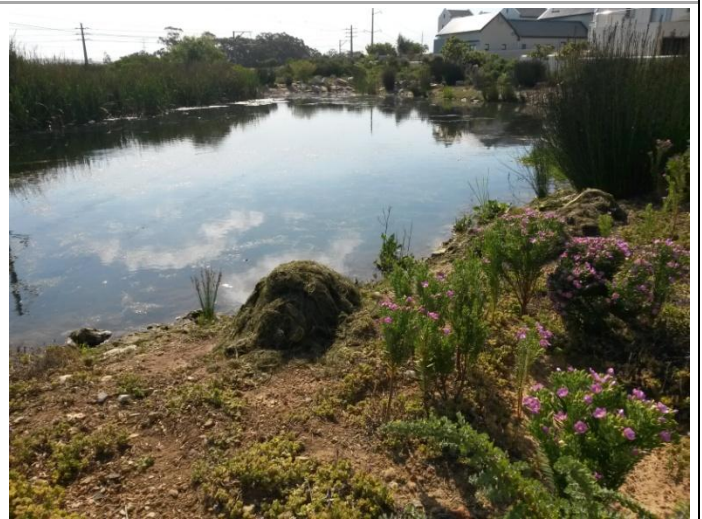
Photo 22: One of the dams near the south-west corner of the Estate. Note the pond weed that has been removed from the dams (piled in the foreground) and is ready to be disposed of.

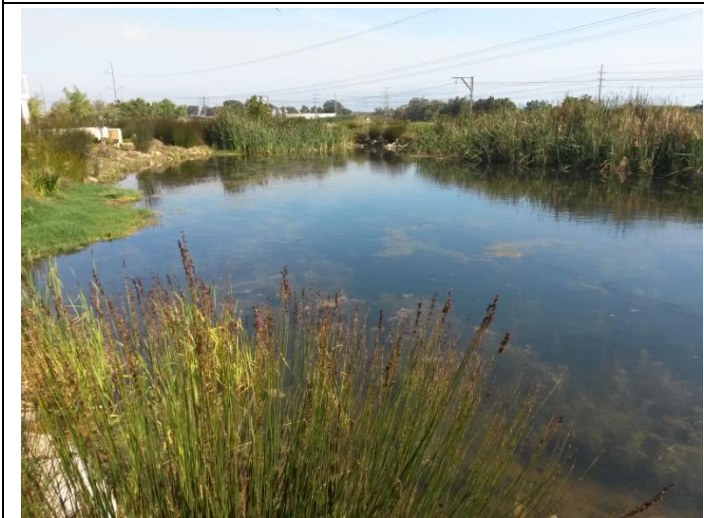
Photo 23: The dam into which the carp have been introduced.
